# Rockdale Gardens

## Interior Light Level Study – Megaman Compact Reflector GU10

Demand Management and Planning Project  
(DMPP)

S6006 001

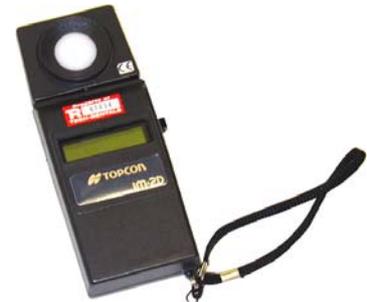
A Topcon illumination meter IM-2D (Serial No. 00426086) rented from Tech-Rentals (Asset No. 87330) was used to measure the lux levels of the test area. The meter was last calibrated by LightLab International on 16 March 2005 and the Photometric Test Report is attached as Appendix B.

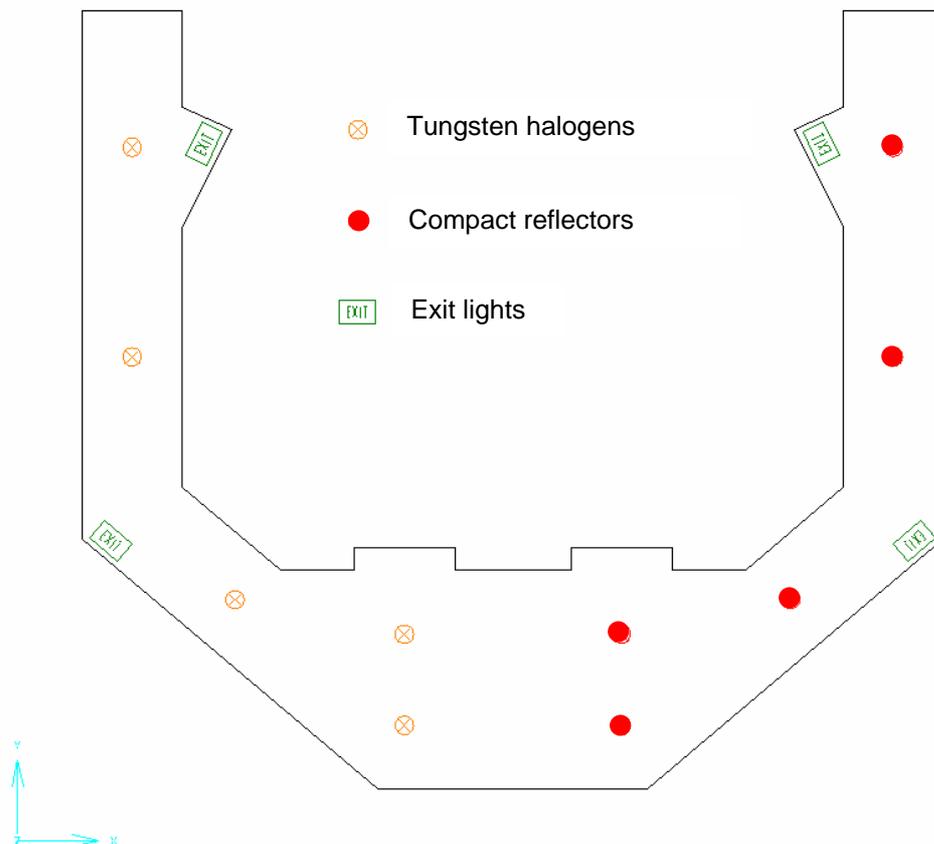
reflectors are rated at 9W and the tungsten halogens at 20W (lamp only). Four emergency exit lights are also present in the surveyed area. The models of the lamps in this study are:

Tungsten halogen lamps – BriLight Tungsten Halogen GU 5.3 MR16 12V 20W BAB 38°

Compact reflector lamps – Megaman Compact reflector GU10 BR0709i (9W, 4000K coolwhite)

The diagram below shows the distribution of the fittings.

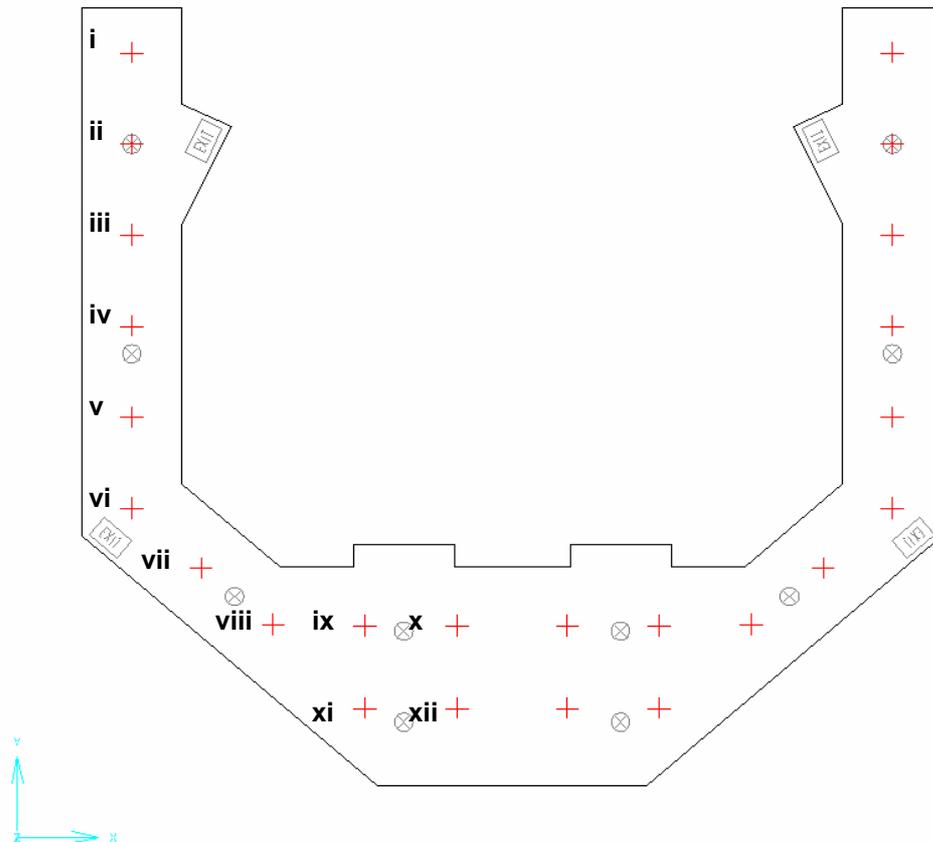
The measurement locations are shown in the diagram below.

Corridor		
Measurement	Measured Lux level (lx)	Error Corrected Lux level (lx)
i	80.1	85.4
ii	96.1	102.5
iii	58.7	62.6
iv	86.9	92.6
v	28.1	30.0
vi	20.1	21.4
vii	65.5	69.8
viii	151.7	161.7
Average	73.4	<b>78.3</b>

Lift lobby		
Measurement	Measured Lux level (lx)	Error Corrected Lux level (lx)
ix	214.0	228.1
x	242.0	258.0
xi	218.0	232.4
xii	119.0	126.9
Average	198.3	<b>211.4</b>

Uniformity of illuminance =  $21.4/78.3 = 0.27$

Lamp lumen depreciation and luminaire depreciation over the lifetime of the lamps is assumed to be zero due to their short lifetime (1000 – 1300 hours). Thus, the expected average output of the halogen lamps at time of replacement is 73.4 lx and 198.3 lx for the corridor and the lift lobby respectively.

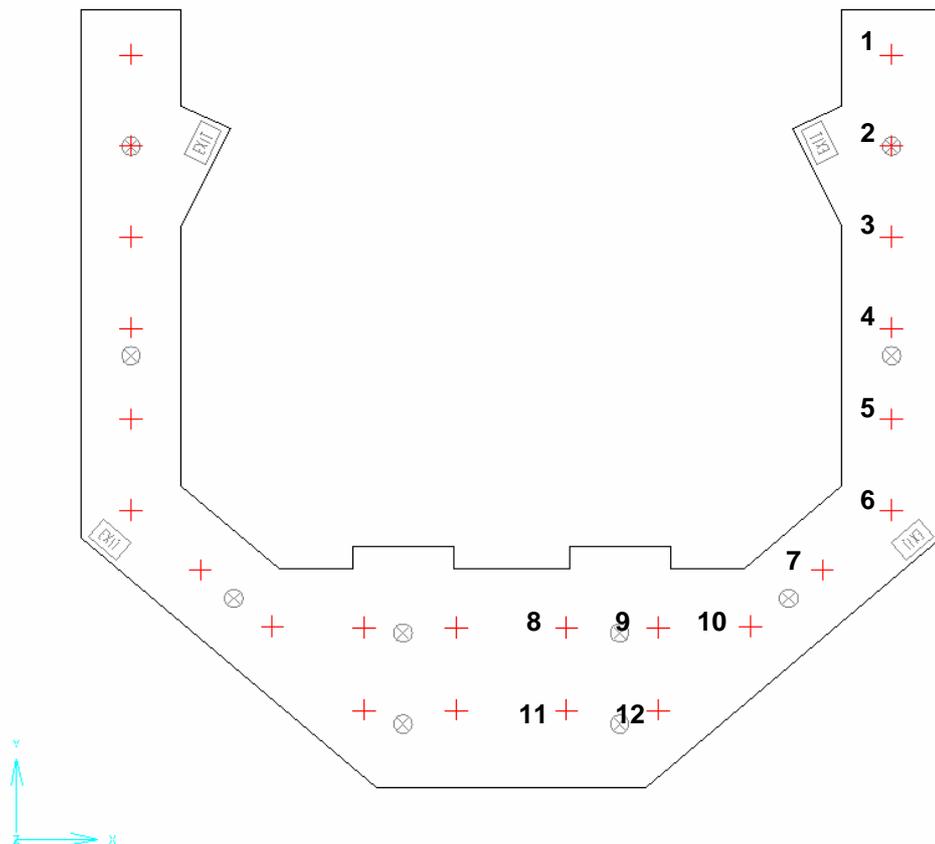
The measurement locations are shown in the diagram below.

Corridor		
Measurement	Measured Lux level (lx)	Error Corrected Lux level (lx)
1	15.5	16.5
2	22.7	24.2
3	24.3	25.9
4	23.7	25.3
5	26.1	27.8
6	27.6	29.4
7	31.0	33.0
8	29.9	31.9
Average	25.1	<b>26.8</b>

Lift lobby		
Measurement	Measured Lux level (lx)	Error Corrected Lux level (lx)
9	36.0	38.4
10	33.8	36.0
11	40.3	43.0
12	34.2	36.5
Average	36.1	<b>38.5</b>

Uniformity of illuminance =  $16.5/26.8 = 0.62$

Thus, the expected average output of the compact reflector lamps at time of replacement is **18.8 lx** and **27.0 lx** for the corridor and the lift lobby respectively.

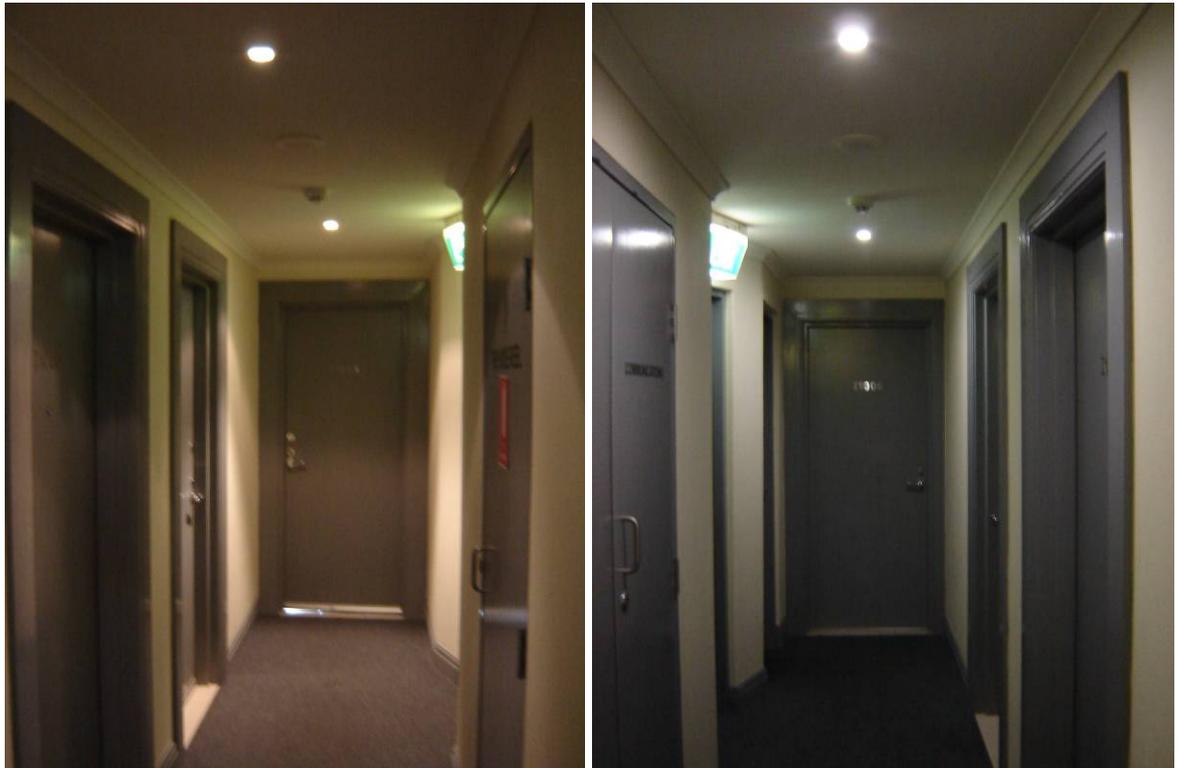
The field measurements of light level indicated that the 9W compact reflector lamps are substantially less bright than the tungsten halogen lamps and do not comply with the illuminance level recommended by AS1680.2.1-1993.

The photos below demonstrate the contrast in illuminance between the two types of light fitting, with the tungsten halogens on the left and the compact reflectors on the right.

As shown in the photos above, the light distribution of the tungsten halogen downlights is much more focused in the downward direction while the compact reflectors have a comparatively wide angle of light distribution. This study found that the uniformity of illuminance provided by the tungsten halogens is below the level recommended by the Australian Standards.

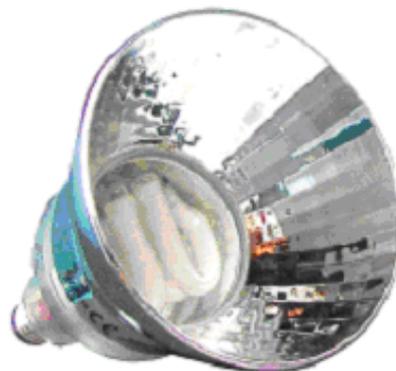
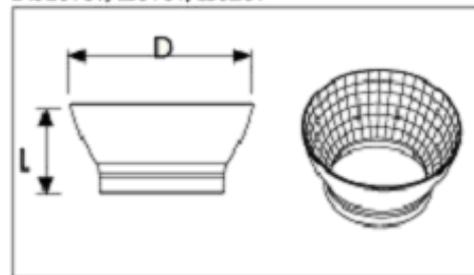
**LA0201SV**  
FOR R50/GU10

Diameter (mm)	82
Length (mm)	52

The recommended light level may be achieved by upsizing to the 11W compact reflector model (BR0711i) with the snap-in reflector (LA0201SV) attached (see picture below). However, the snap-in reflector attachment may adversely affect illuminance uniformity of the compact reflectors. The actual result of this strategy can only be confirmed from a field measurement.

Minimum light levels according to AS 1680 may be achieved with the 11W compact reflector model and the use of the snap-in reflector attachment although this would require verification with a field measurement.

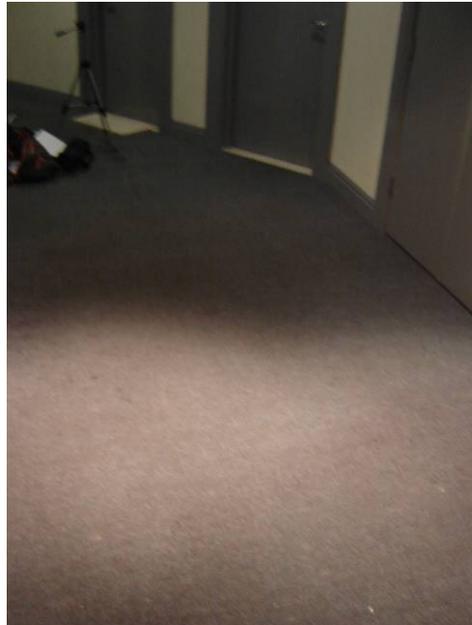
Below: Contrast between the tungsten halogen (foreground) and the compact reflector (background) as seen at the lift lobby.

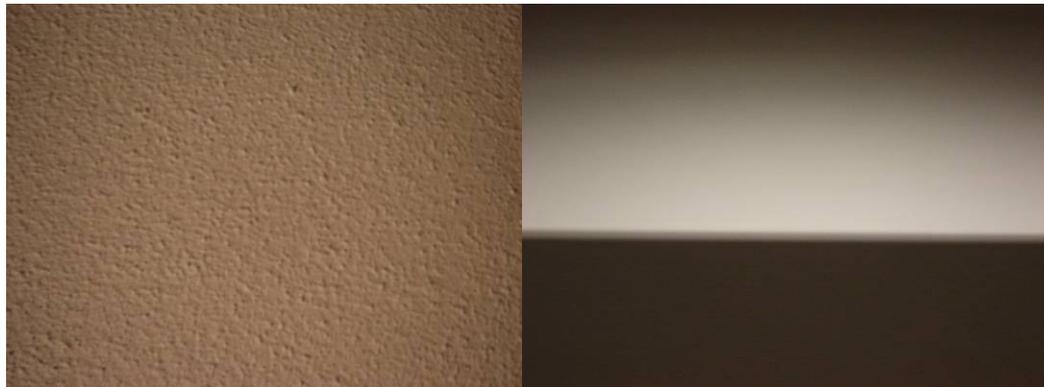
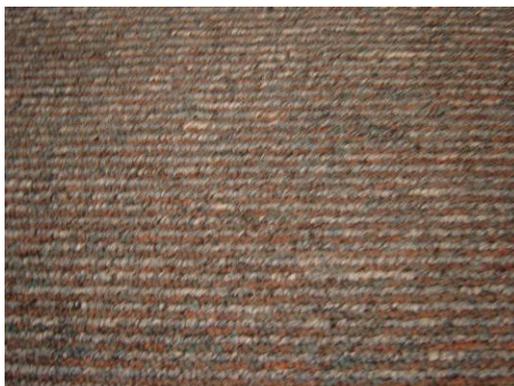
Ceiling	– clean
Walls	– clean
Floor	– average

Clockwise from bottom: Floor; wall; and ceiling finishes in the lift lobby.
